# **BYD Battery-Box Premium HVS&HVM**

## **Service Guideline and Checklist for BCU-V2.0**

Version 1.1

Valid for HVS 5.1 / 7.7 / 10.2 / 12.8  
HVM 8.3 / 11.0 / 13.8 / 16.6 / 19.3 / 22.1

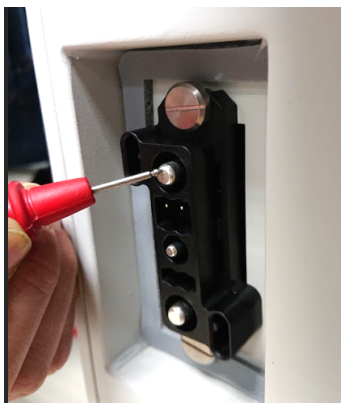
**Positive**

### Measurement of Individual Module Voltage
